LIVESTOCK INSPECTION DIGITAL PHOTOGRAPH PHOTOCOPIES

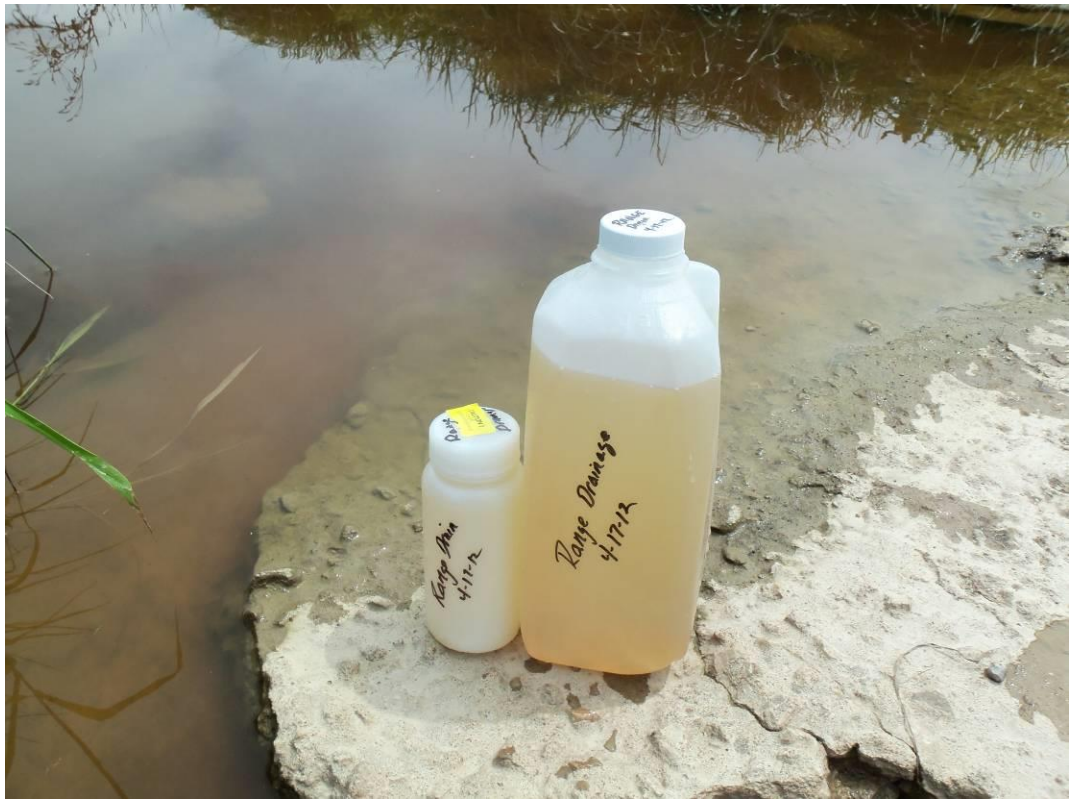
Photo # 026
Date: April 17, 2012
Time: 1:24 p.m.
Taken By: Brian Rodely DWPC/FOS
Facility: KJMM Range Farm
Location: E Range Ln & Drain Ditch.
Notes: Sample of the Range Farm Drainage Ditch is shown in the adjacent photo. The sample was taken on the east side of the intersection of Range Ln and the Drainage Ditch.

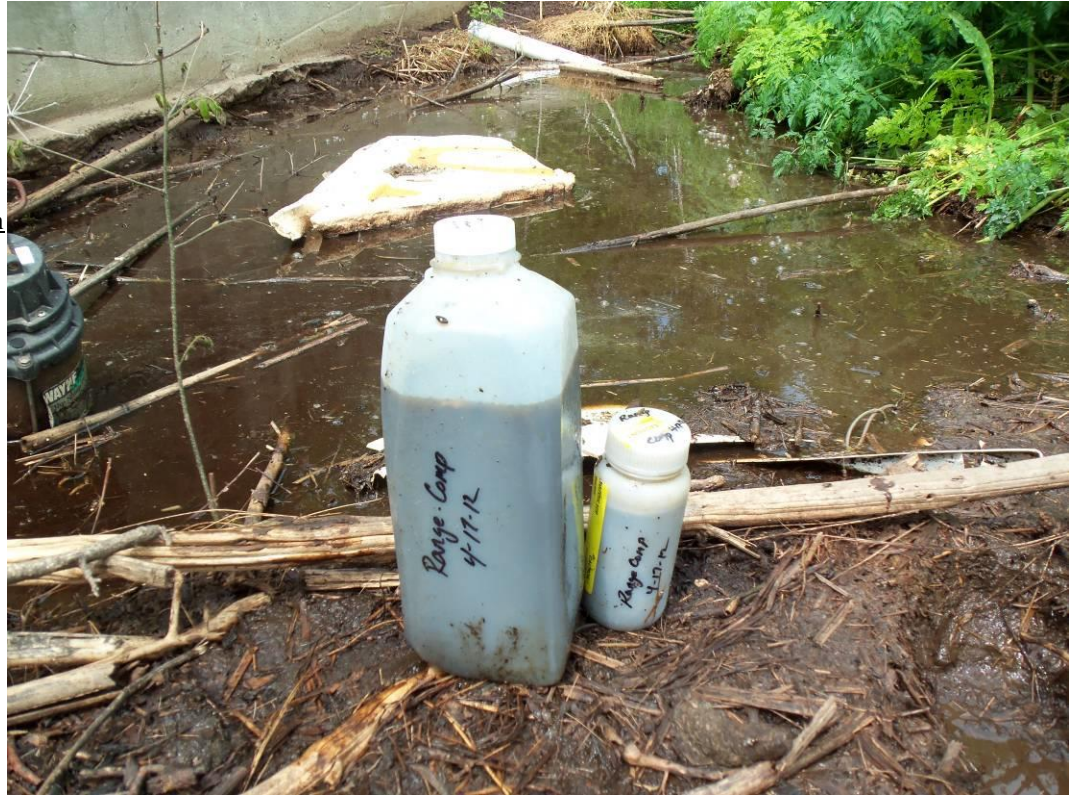
Photo # 027
Date: April 17, 2012
Time: 1:32 p.m.
Taken By: Brian Rodely DWPC/FOS
Facility: KJMM Range Farm
Location: E Compost Bin.
Notes: Sample of the Range Farm
compost leachate pooled on
the eastern side of the
compost operation. A
submersible pump can be
seen in the photo left that
appears to have been non-
functional for some time.

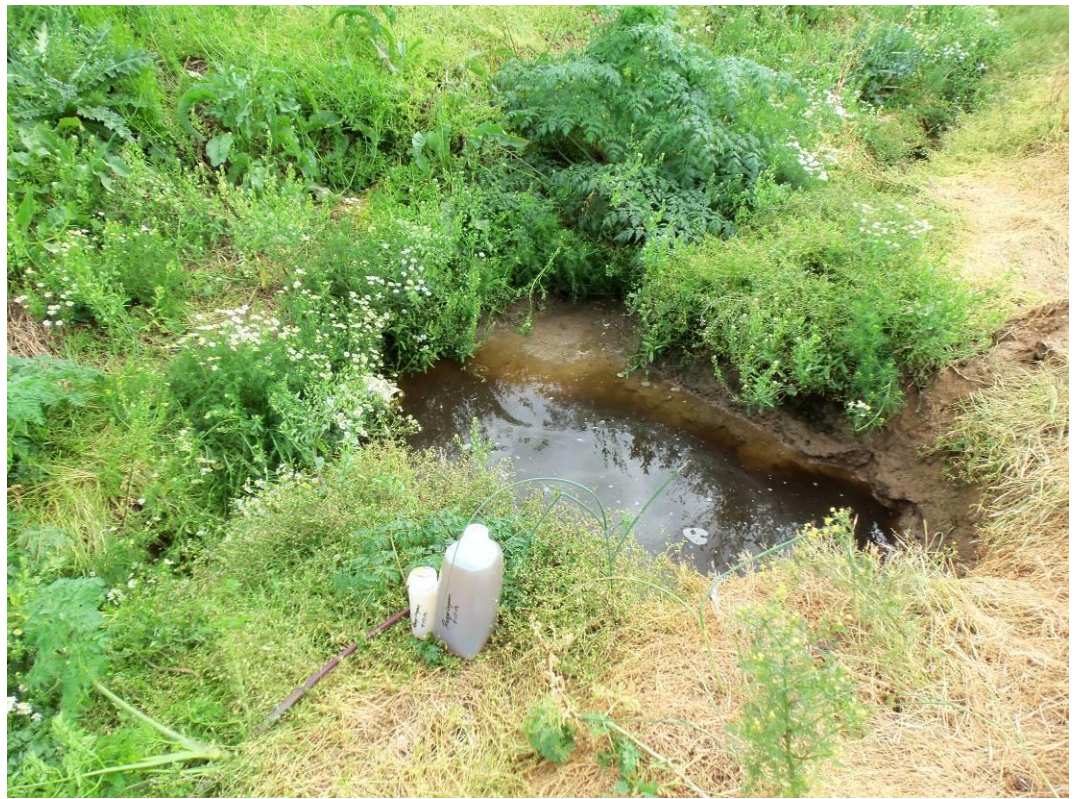
Photo # 028
Date: April 17, 2012
Time: 1:42 p.m.
Taken By: Brian Rodely DWPC/FOS
Facility: KJMM Range Farm
Location: W Stage 3 Face S.
Notes: Sample of the Range Farm
lagoon discharge can be
seen in the adjacent photo.
